June 28, 2019
File No. 262018.063

Subject: Department of Natural Resources Washington Geological Survey,
School Seismic Safety Assessment Project, Contract No. AE 410 -
Seismic Evaluation for **Darrington School District**

School Buildings Evaluated in the Darrington School District

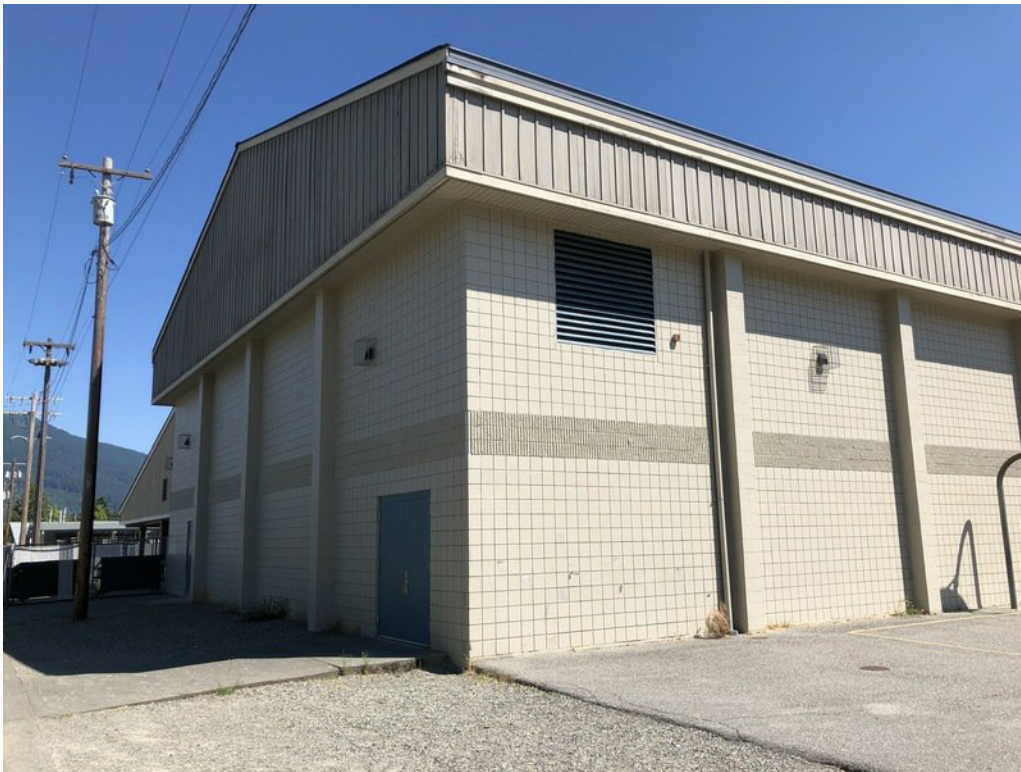
Figure 1-4. Exterior south side of building. Note the concrete columns.

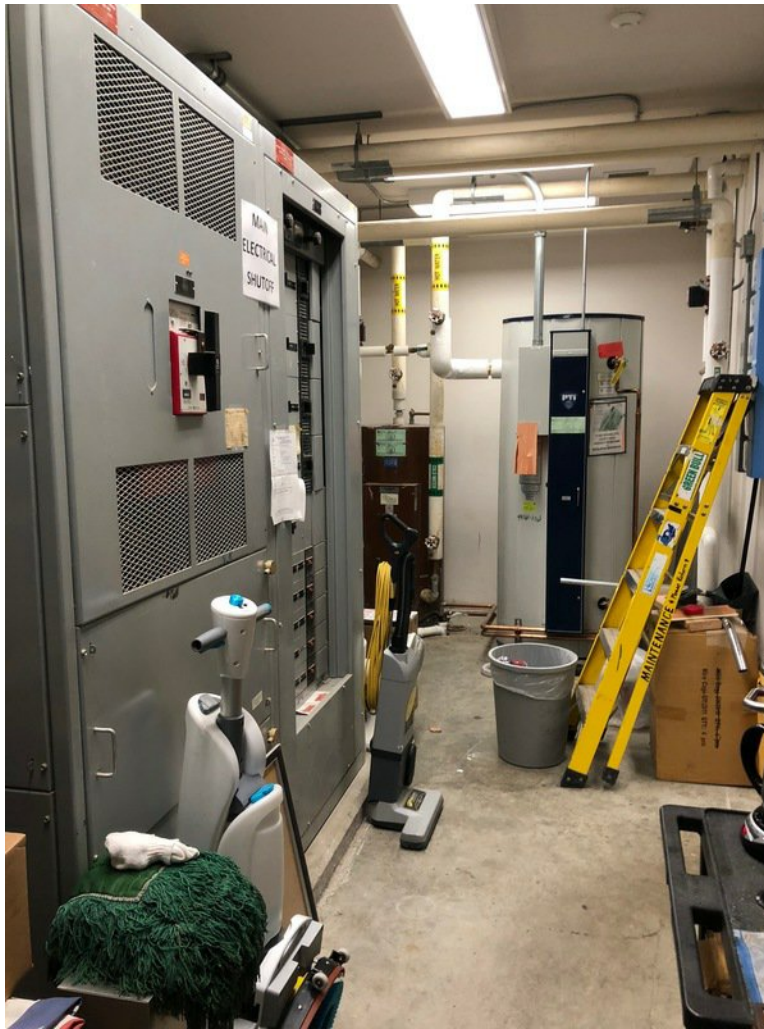
Figure 1-7. Interior mechanical room with equipment susceptible to earthquake shaking. Inadequately braced equipment may benefit from additional bracing.

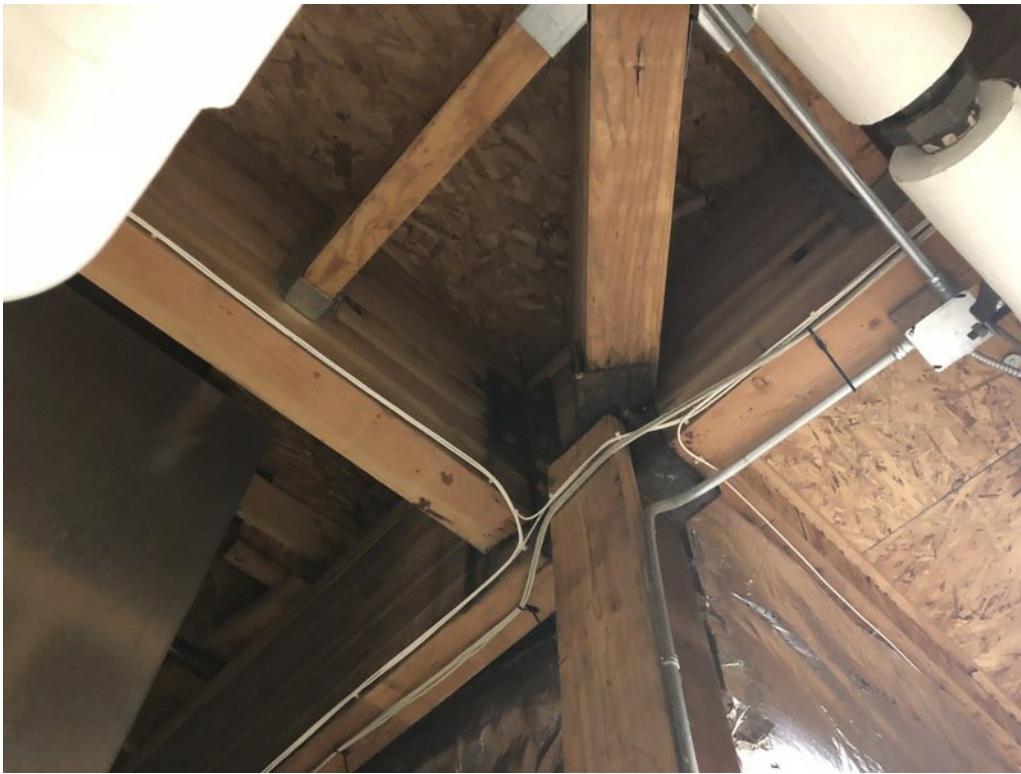
Figure 1-3. Interior attic area. The girders are strapped to the columns with Simpson ST22 that provide a positive connection at the girder-column interface.

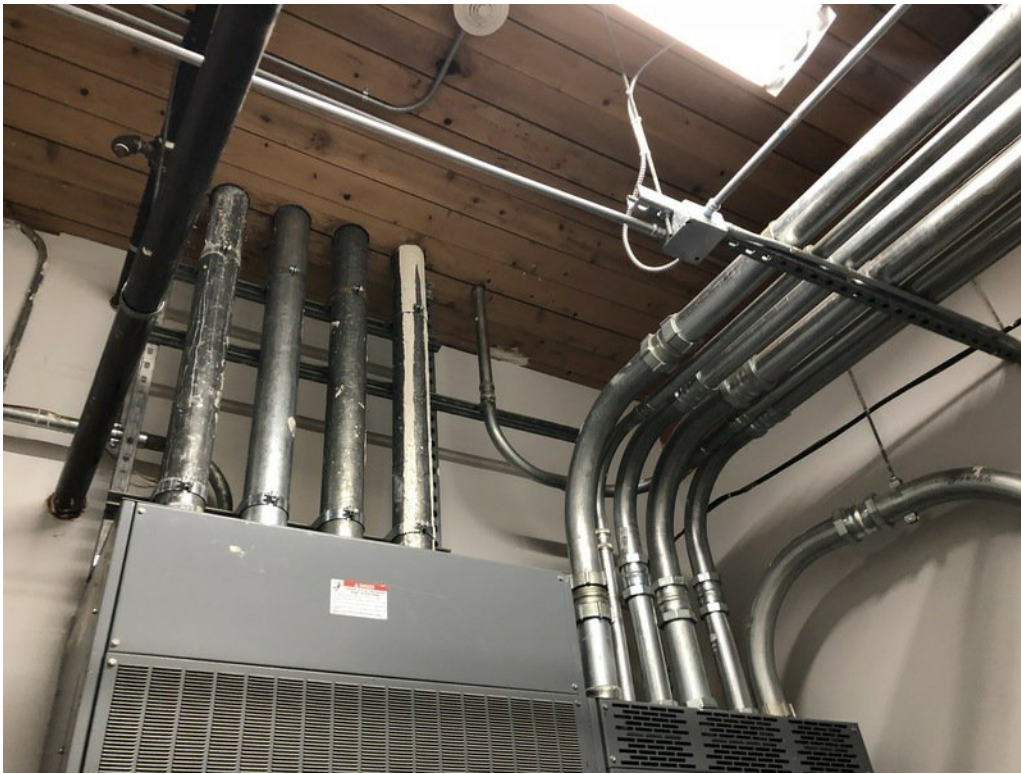
Figure 1-5. Conduit for nonstructural systems. Further investigation is recommended into the bracing of the conduit and whether the bracing is adequate for life safety hazards due to falling objects or if building life safety systems (e.g. fire sprinkler controls) are operated by systems within these conduit.

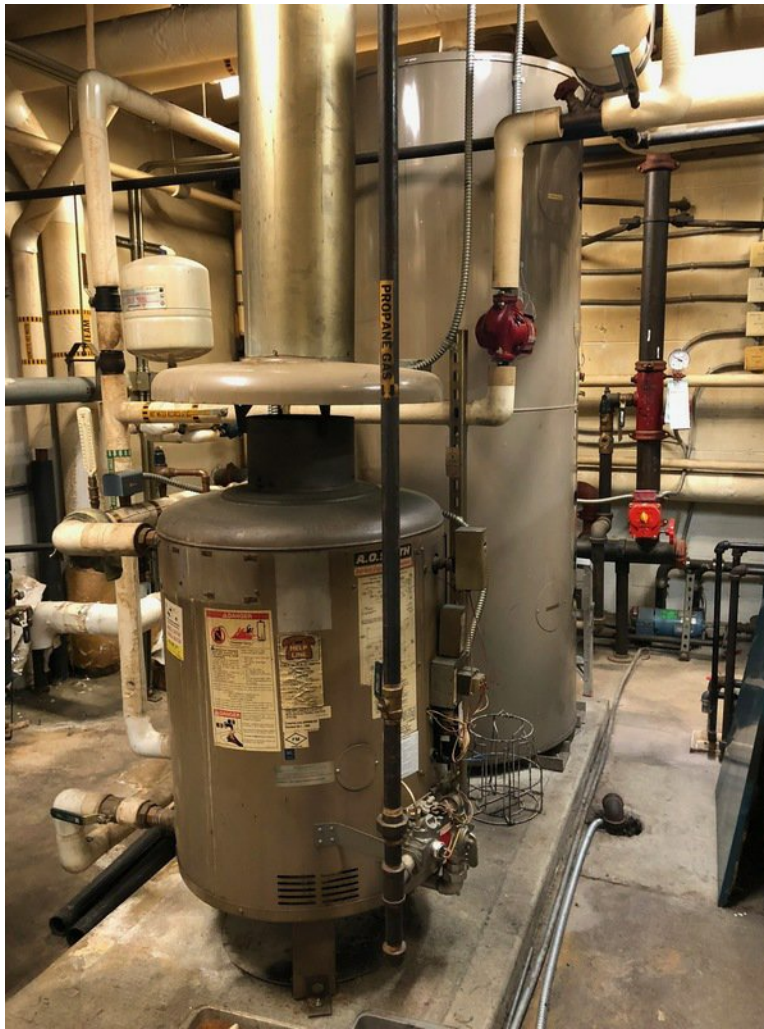
Figure 1-6. Large mechanical equipment that includes propane gas piping. Further investigation is recommended to determine whether bracing and anchorage is adequate. Additional bracing and/or flexible couplings for piping may be appropriate to reduce earthquake hazards.

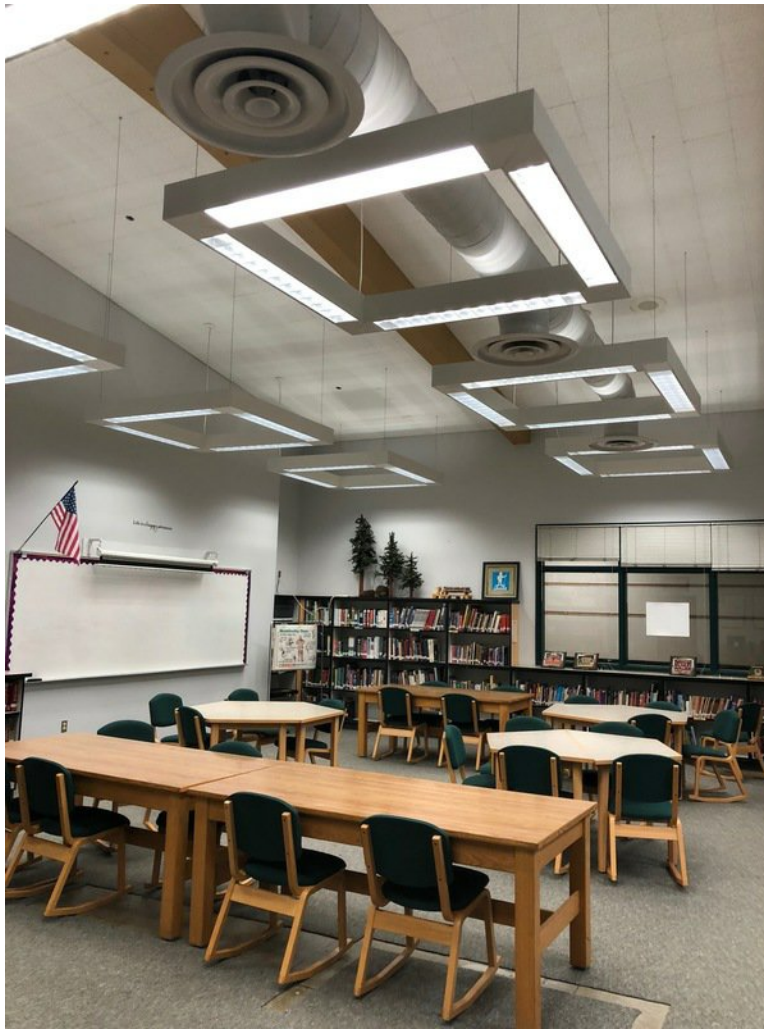
Figure 1-7. Interior library. Lights are suspended on unbraced wires from ceiling. Further investigation and evaluation is recommended to be conducted to determine whether lights are able to swing freely without being damaged in an earthquake and, or if existing supports are adequate. Alternative lighting support may be appropriate to protect occupant life safety in an earthquake.

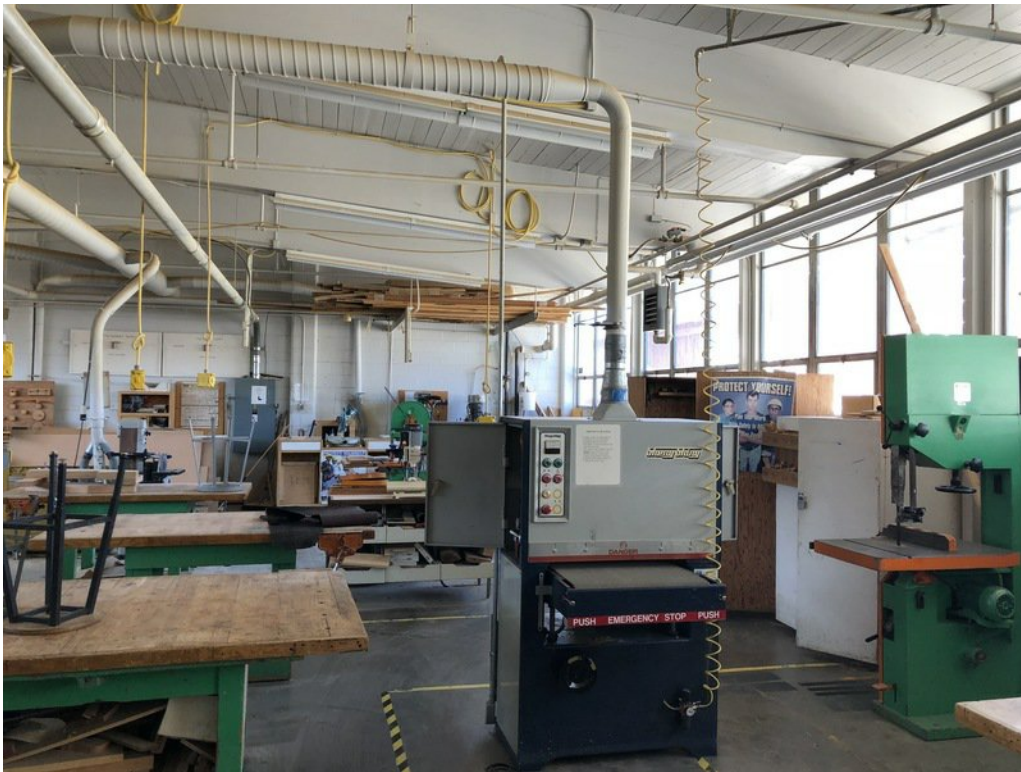
Figure 1-3. Interior of Woodshop Building. Note that piping does not appear to be laterally braced. Bracing could be provided to increase seismic strength.

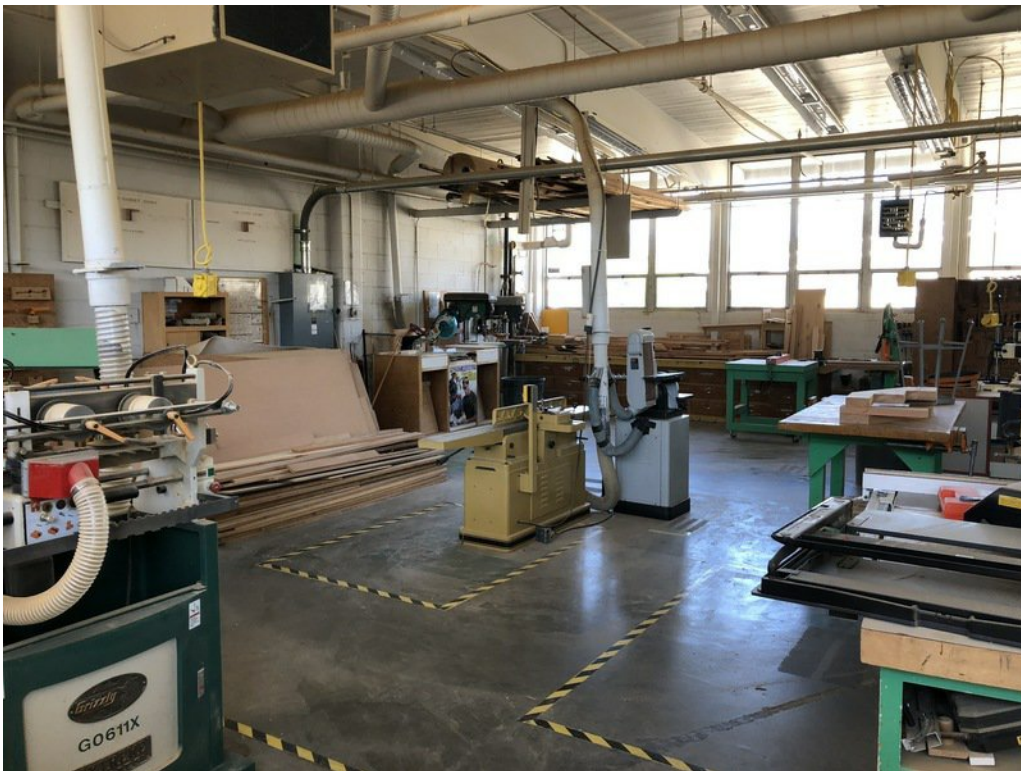
Figure 1-4. Interior of Woodshop Building. Note that what appears to be a natural gas space heater does not appear to have flexible couplings or lateral bracing. Flexible couplings and lateral bracing could be provided to improve seismic performance.

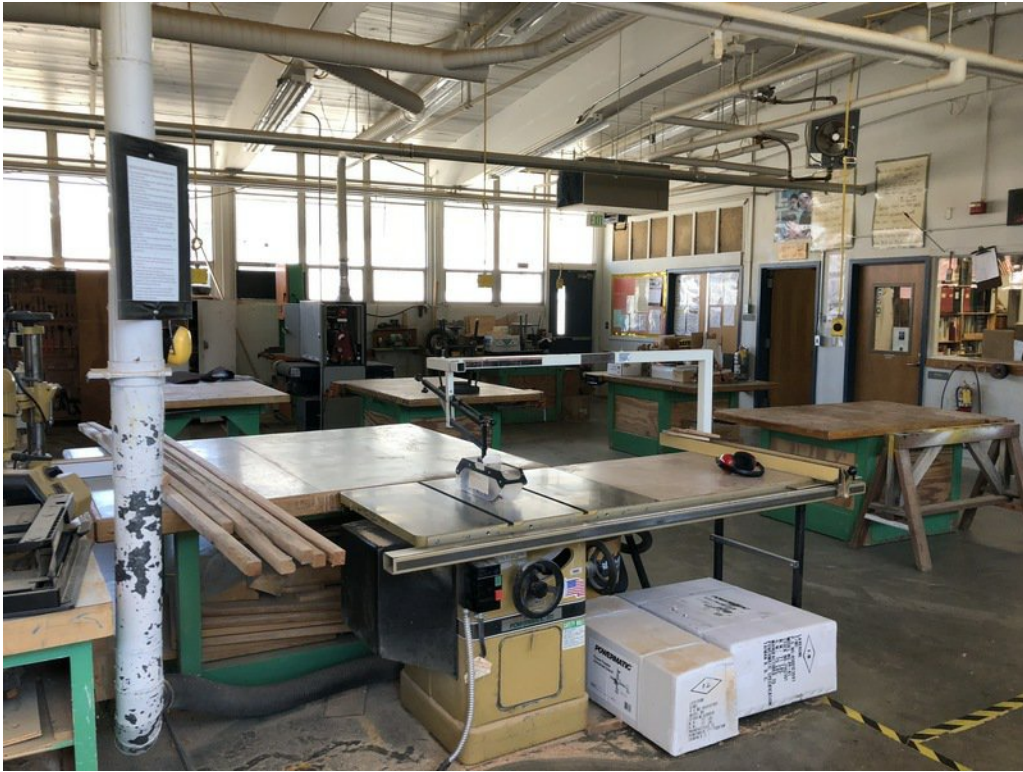
Figure 1-5. Interior of Woodshop Building. Note that heavy suspended equipment does not appear to be laterally braced. Bracing could be provided to increase seismic strength.
